# Southern Highway Mile 14 to Jalacte Junction Road Upgrading Project

## Progress Report

For the Period Ending December 2013

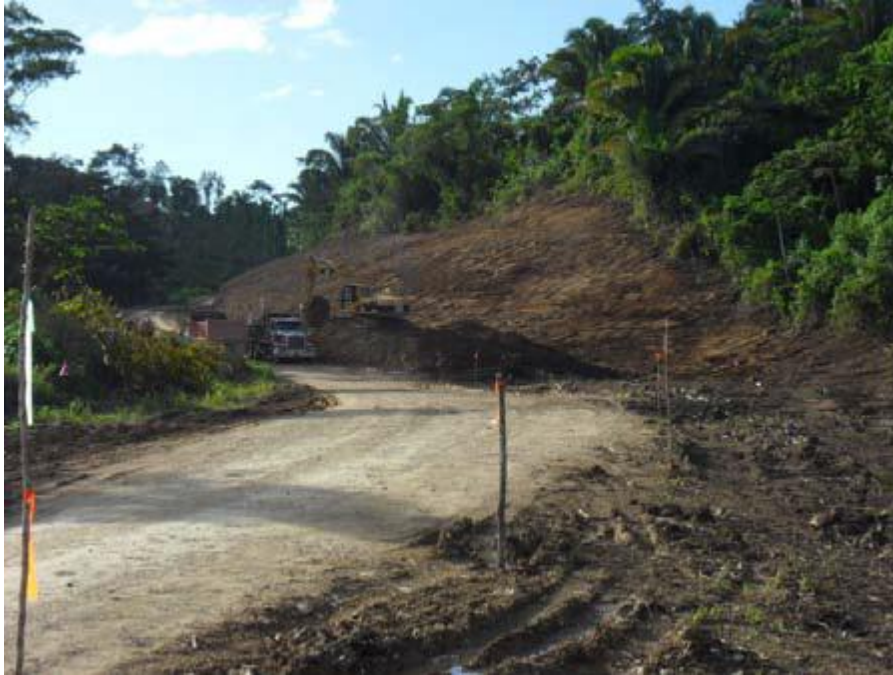
Photo 1: Earthworks at Ch20800m - Rio Blanco realignment.

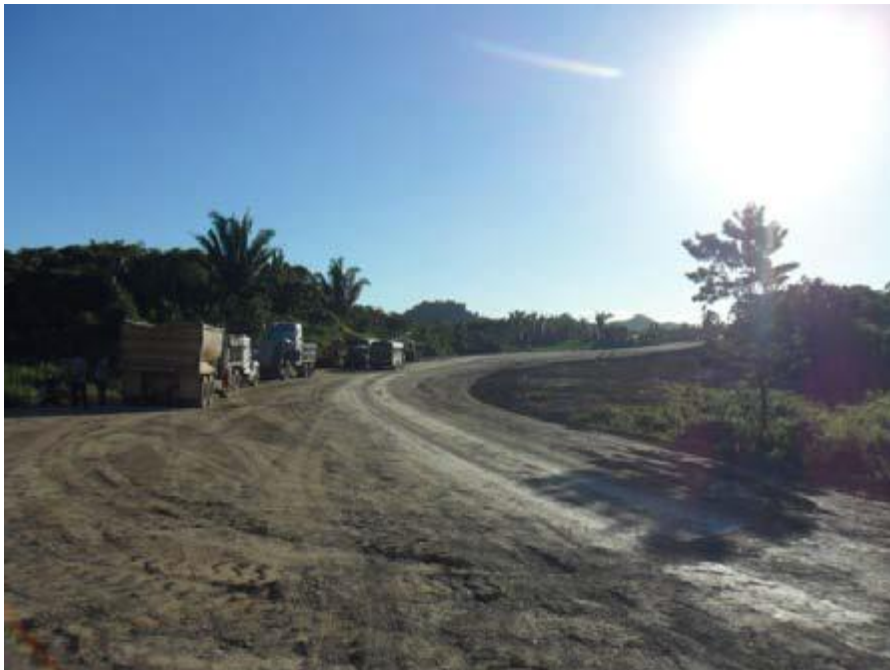
Photo 2: Earthworks at Ch 28500m.

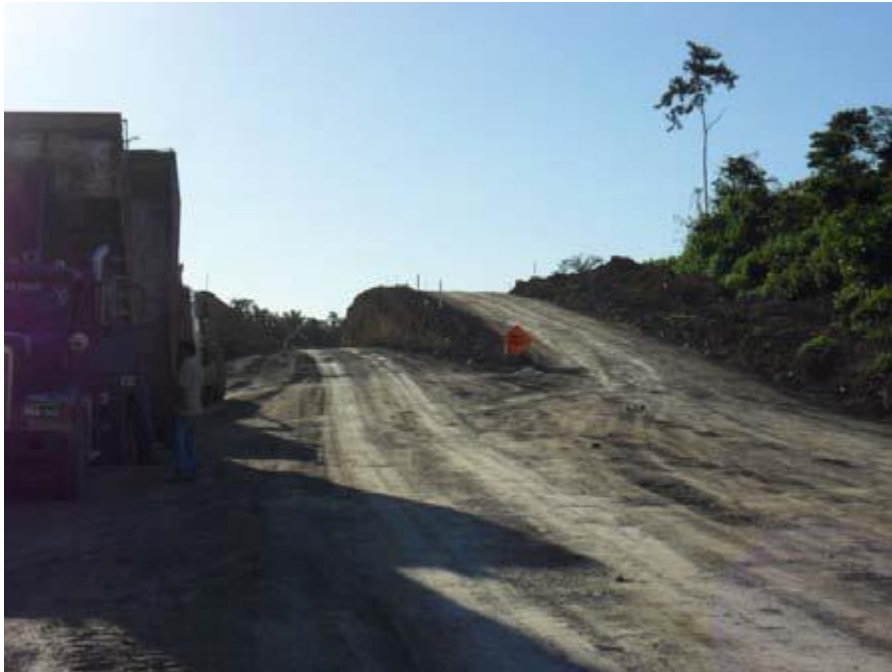
Photo 3: Earthworks at Ch 28780m.

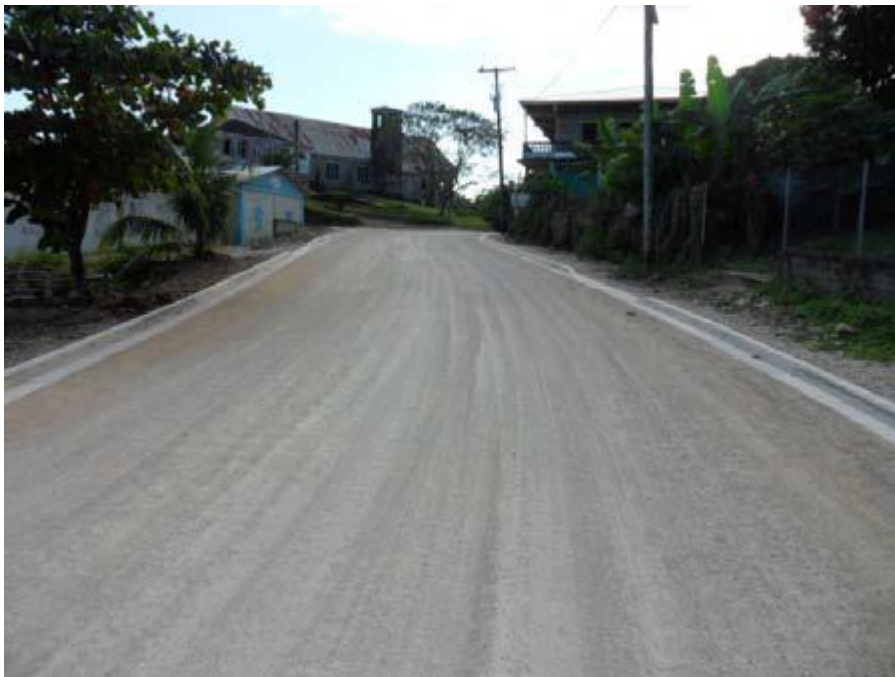
Photo 4: Kerb and channel and basecourse work completed in the centre of San Antonio Village. First coat seal recently completed.

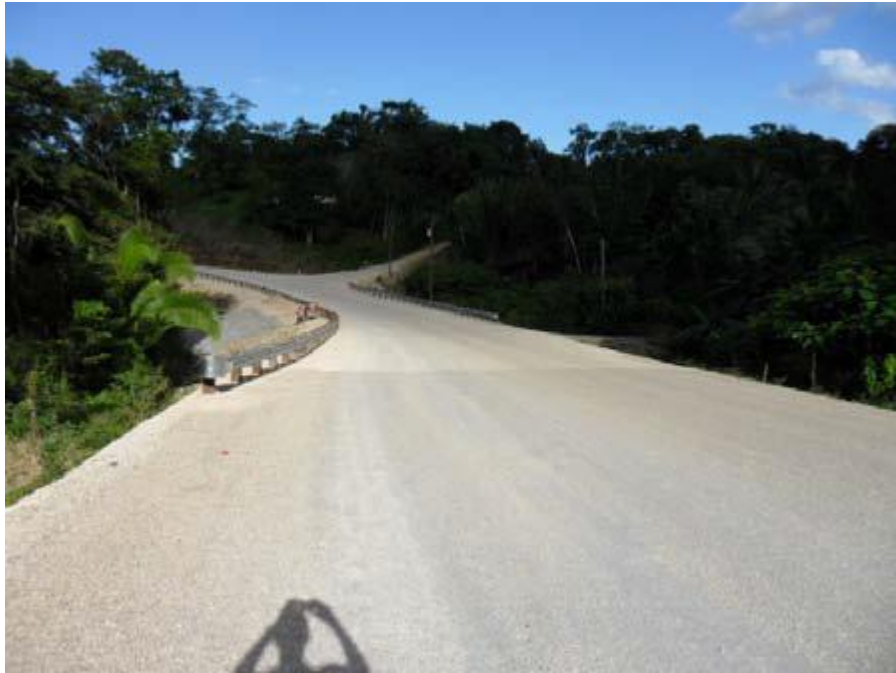
Photo 5: Guardrail being installed at Ch 11400m (San Antonio Village).

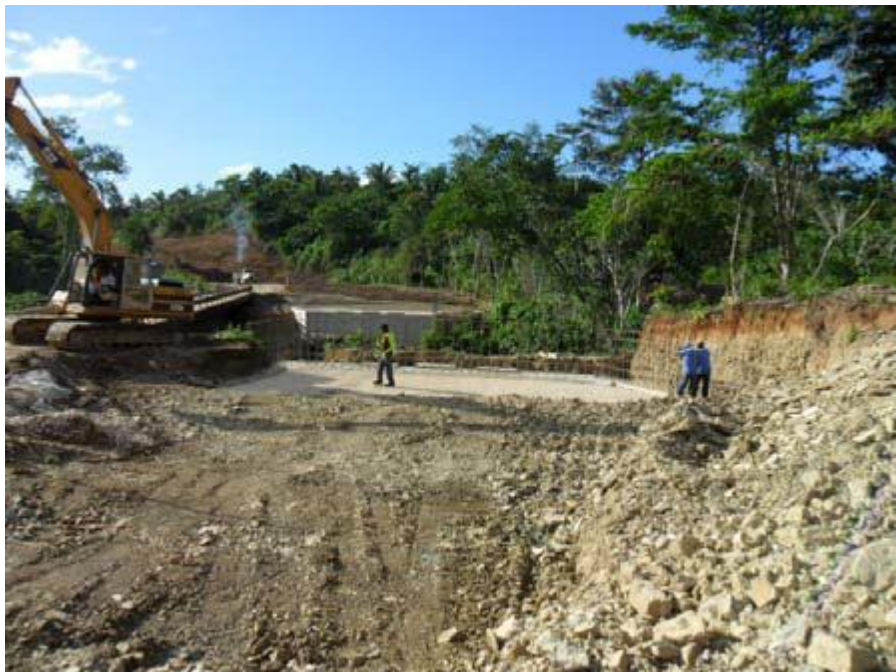
Photo 6: -Rio Blanco Bridge - Abutments cast to bearing shelf level. Area backfilled awaiting arrival of bridge beams.
