Southern Highway Mile 14 to Jalacte Junction Road Upgrading Project

Progress Report

For the Period Ending February 2014

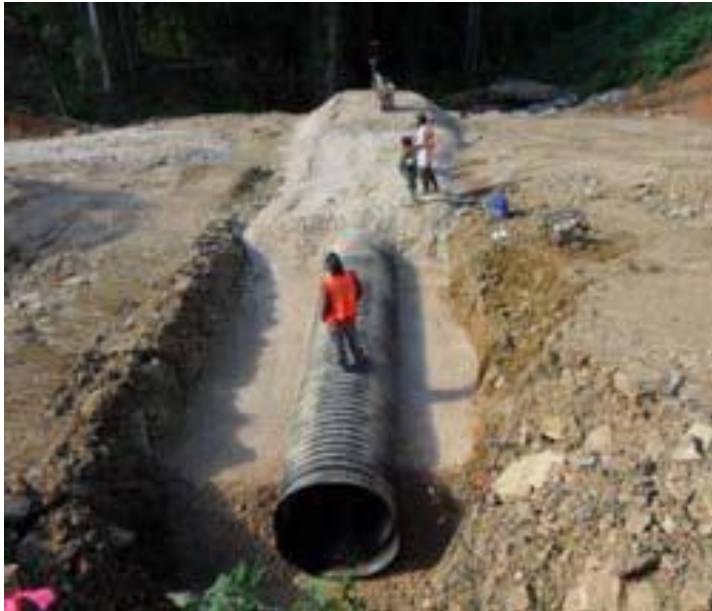
Photo 1: Culvert being installed at chainage 28350m

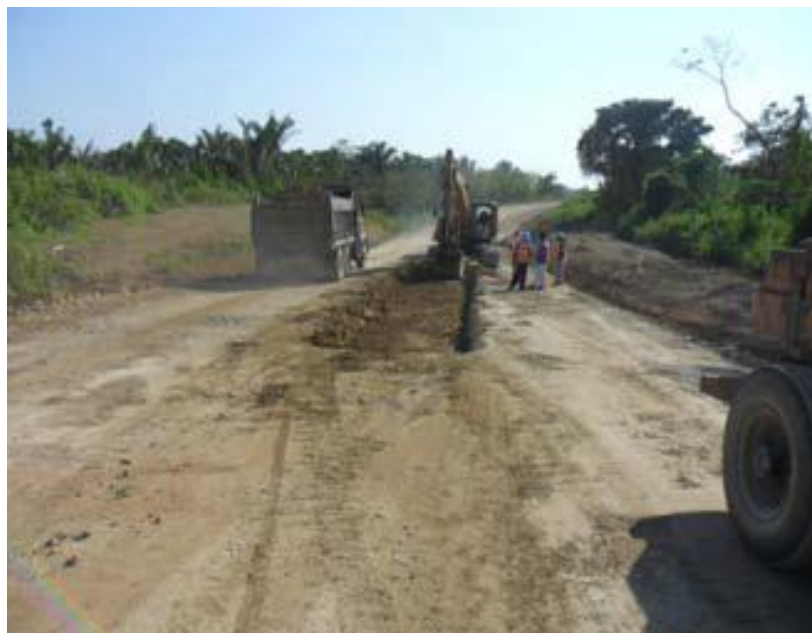
Photo 2: Undercutting wet subgrade -approx chainage 24180m – pueblo Viejo Village.

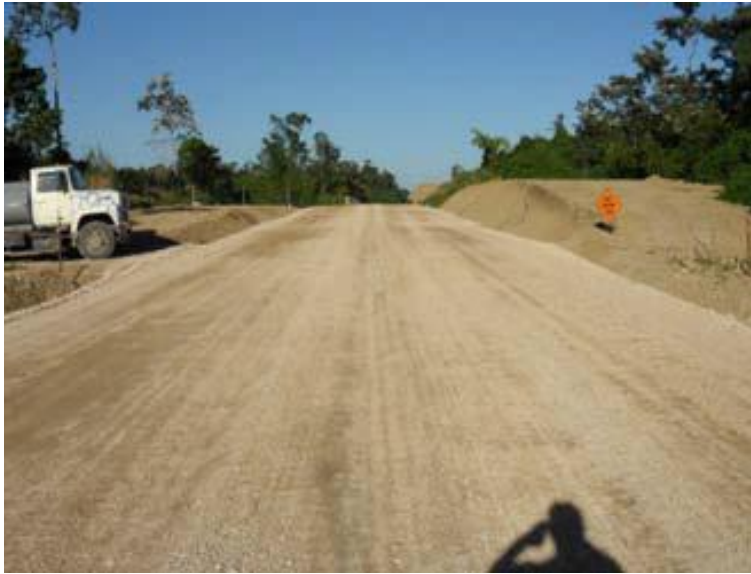
Photo 3: Subgrade preparation at approx Ch24400m

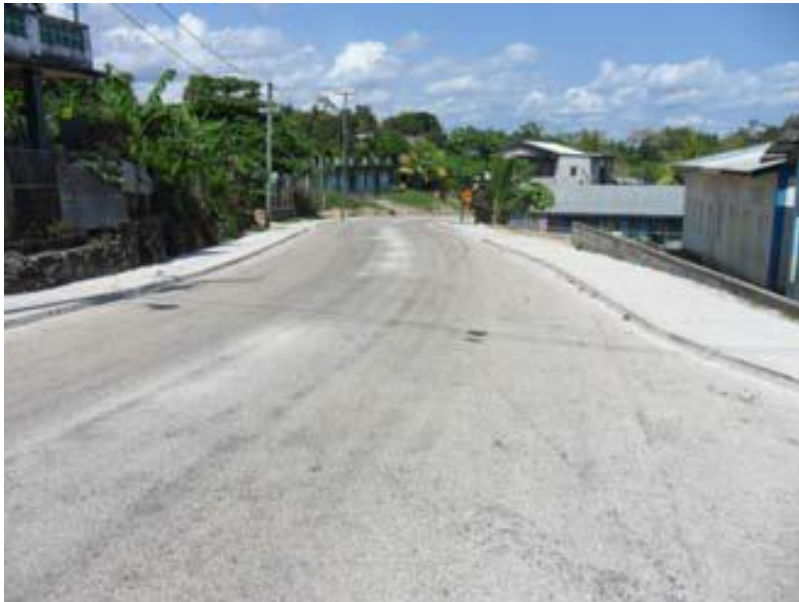
Photo 4: San Antonio Village- 1st coat seal and concrete footpaths.

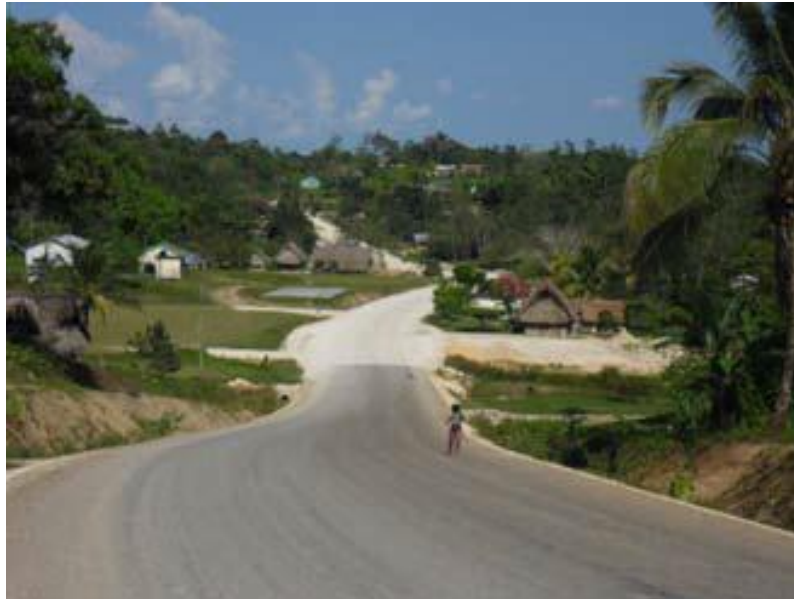
Photo 5: Extention of 1st coat seal into Santa Elena Village.

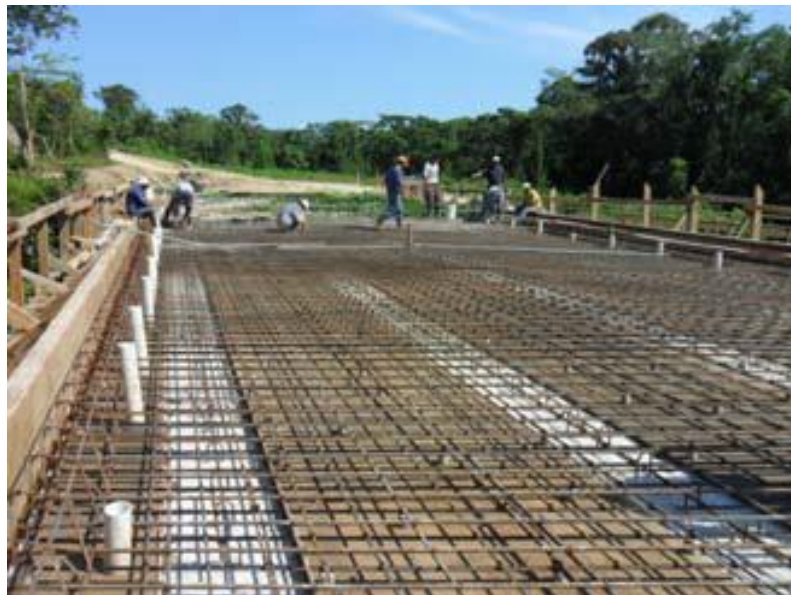
Photo 6: -Rio Blanco Bridge - placing deck steel.
