Southern Highway Mile 14 to Jalacte Junction Road Upgrading Project

Progress Report

For the Period Ending January 2014

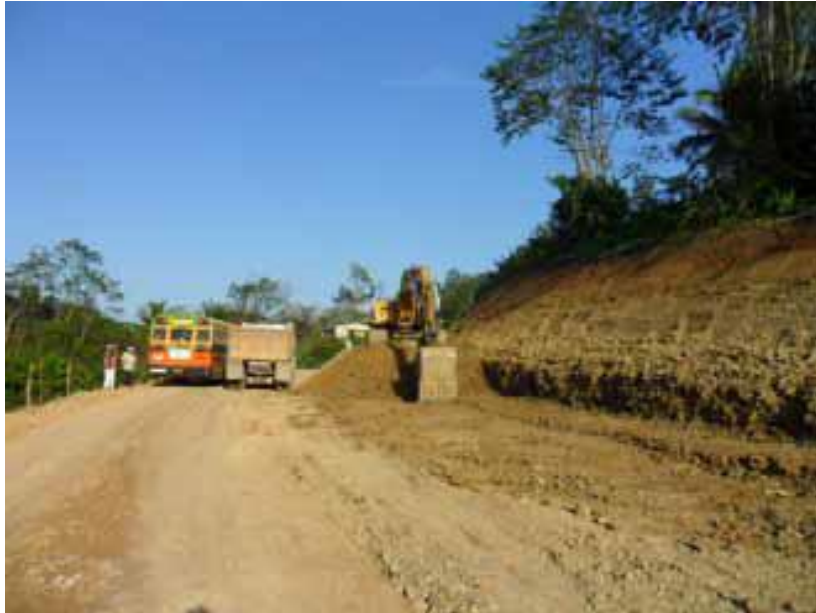
Photo 1: Earthworks at Ch26400m - Pueblo Viejo Village.

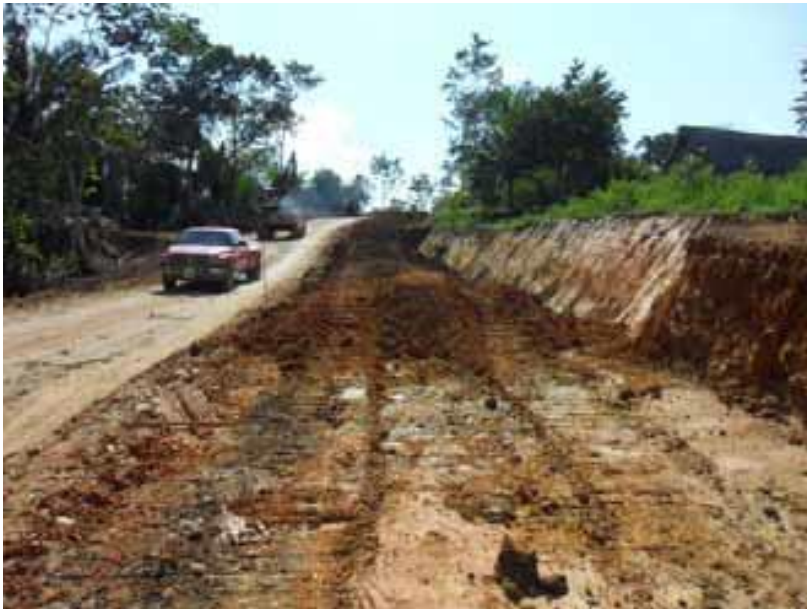
Photo 2: Earthworks at Ch 26700m- pueblo Viejo Village

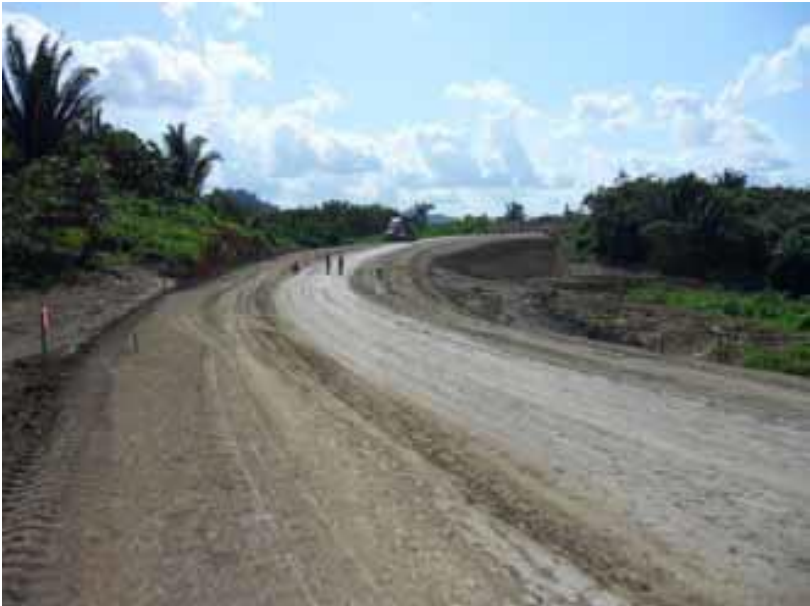
Photo 3: Subgrade nearing completion Ch 28500m (approx.)

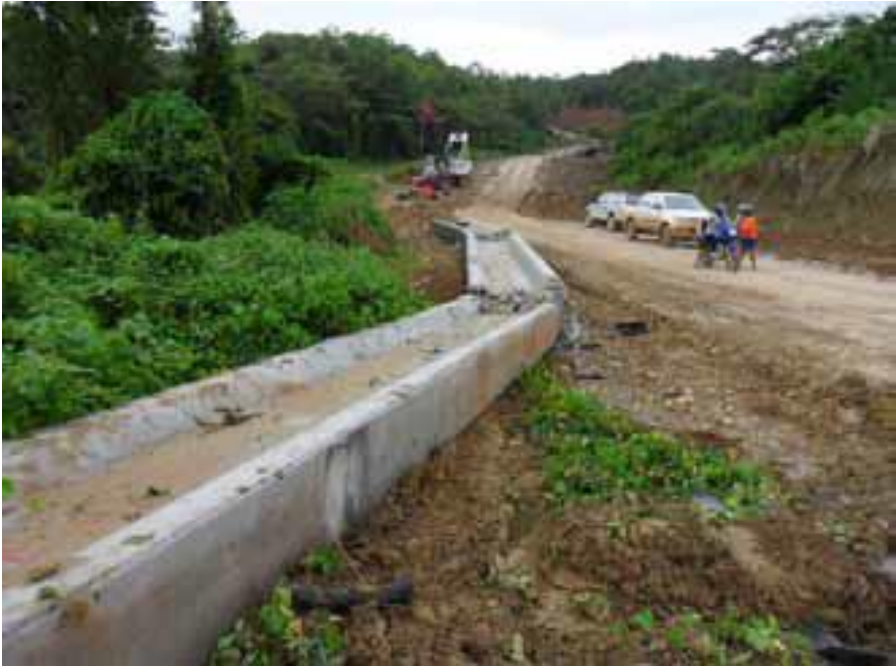
Photo 4: Broken Rio Blanco Bridge beam

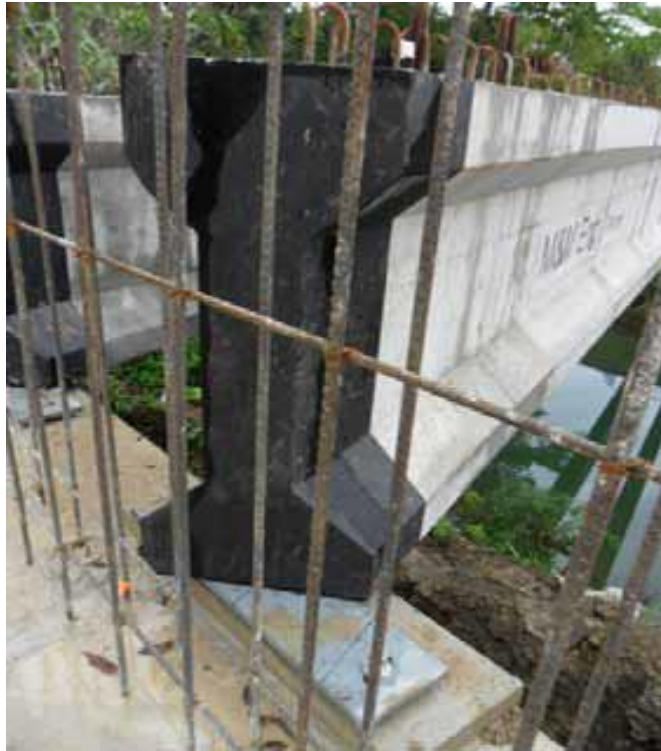
Photo 5: Placement of Rio Blanco Bridge beam showing incorrect skew that was cast into the end of the beams. Design has made amendments to beam base plants and abutment back will accommodate to construction error.

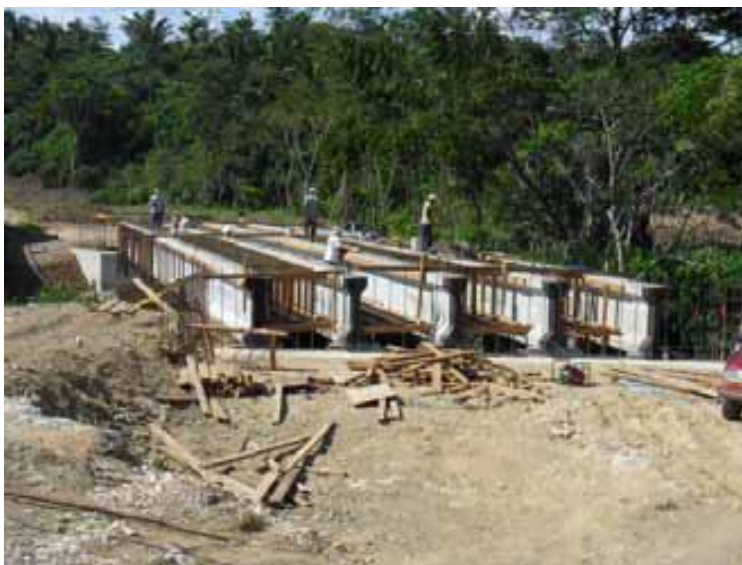
Photo 6: -Rio Blanco Bridge - All beam in place. Formwork being installed for diaphragms.
